Streambank erosion repair

Case study: Streambank erosion repair in the Lockyer Valley

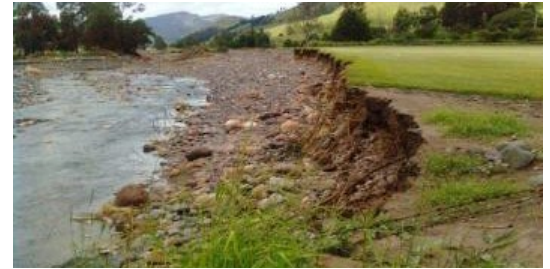
MT SYLVIA: Scouring has occurred here resulting in a very unstable steep bank, impacting on the productive potential of the farm.

MT SYLVIA: A dam on the property had collected sediment and required maintenance and repairs to the dam wall. The landholder was able to spread some of this reclaimed soil over the reshaped bank to help establish vegetation. Turf from the farm provided instant cover whilst deep rooted native vegetation establishes. The bank was battered to a slope of 1 (vertical) to 3 (horizontal), before spreading topsoil and covering with a combination of native plants and turf.

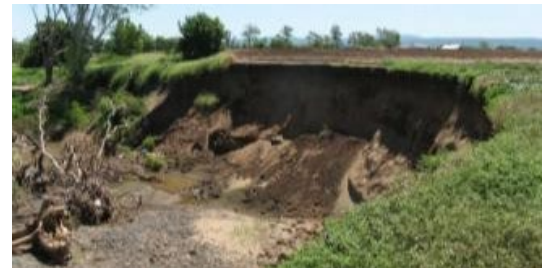
LOWER TENTHILL: Mass failure has resulted in a bank slump in the above example. This poses a serious safety risk to farm traffic and workers.

LOWER TENTHILL: High density angular basalt rock was carefully placed at the toe of this slump using an excavator with a rock grab. The soil behind the rows of rock was compacted before the bank was battered and sown with a cover crop as native plants established. This example highlights the importance of a stable toe to maintain the integrity of the bank and the need for careful placement of the rock to make use of its angularity to interlock the structure.

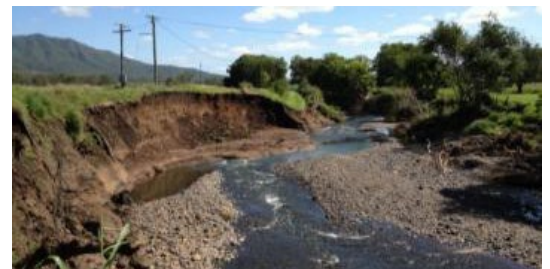
THORNTON: Both mass failure and erosion scour has occurred in the example above resulting in a loss of land and the need to relocate farm tracks and power infrastructure.

THORNTON: Reinforcing mesh was bent into cubes and lined with geofabric before being filled with gravel to create improvised gabions. These cubes were stacked along the bank toe before the bank was battered and planted. This example demonstrates the innovative use of available materials to fabricate a structure with much greater resistance to erosion than soil material alone. The steel reinforced, geofabric lined, gravel filled gabions were carefully keyed into the reshaped bank to reduce the likelihood of outflanking. Structures such as these are designed to provide stability to the bank whilst vegetation becomes established as the long term solution to reducing streambank degradation.

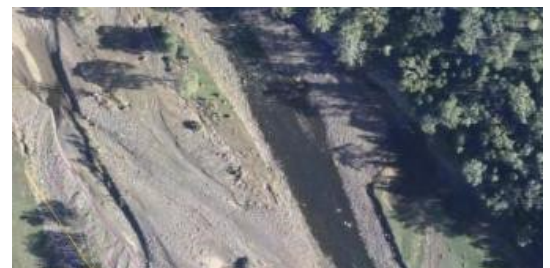
EAST HALDON: Scour has caused the stream to widen and the low flow channel to change course. Land used for grazing has been lost along with fences. Infrastructure on the floodplain has suffered impact.

EAST HALDON: This bank was reshaped before being covered with topsoil to improve conditions for plant establishment. Care was taken not to disturb the line of trees (refer front cover and to the right of the above images) that survived the flood event and retain them along the bank toe. This example illustrates the importance of incorporating existing riparian vegetation into the streambank restoration design and, where possible, including any local topsoil reserves to create a better environment for plant growth.
