Streambank erosion repair

Case study: Streambank erosion repair in the Laidley Creek

This case study outlines the steps taken in restoration activities in Laidley Creek after the 2011 and 2013 flood events. This is a complex example involving a number of stages to address multiple threatening processes occurring simultaneously.

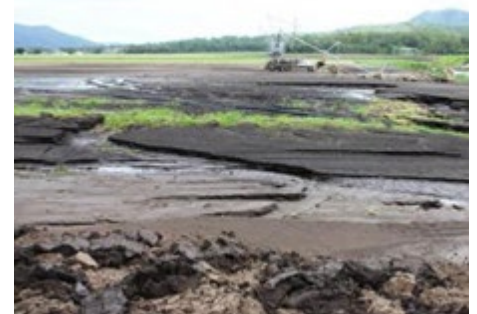
Soil cover in the form of mature crops can minimise topsoil loss and reduce impacts on farm productivity.

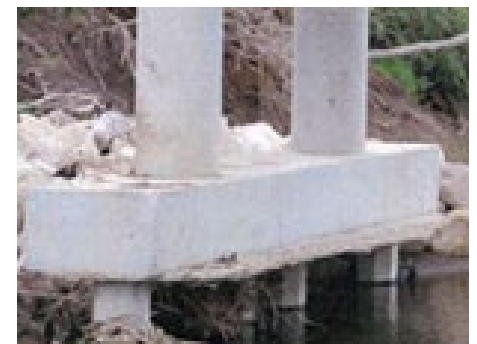
Critically, the creek bed suffered from erosion and lowered in response to the flood. Bed lowering affects not only infrastructure such as the foundation of bridges, but also the stability of the streambanks as they typically widen in response to bed lowering.

Streambed lowering impacts on structural integrity of man-made assets as well as the stability of streambanks.

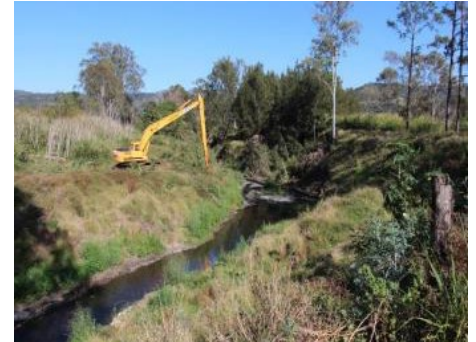
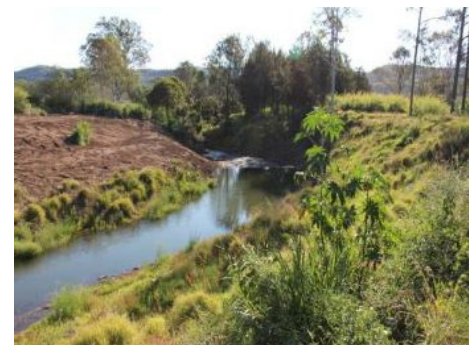
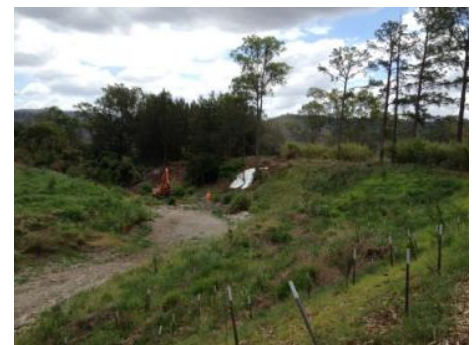
Photo points have been taken to build a picture of progress over time from before the start of works and will continue into the future.
