## Assessing Ecosystem Health in Moreton Bay and its River Estuaries

# Moreton Bay 2000 Report Card

# River Estuary 2000 Report Card

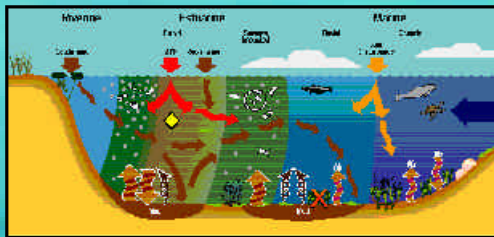
Current conceptual model of Moreton Bay and river estuaries

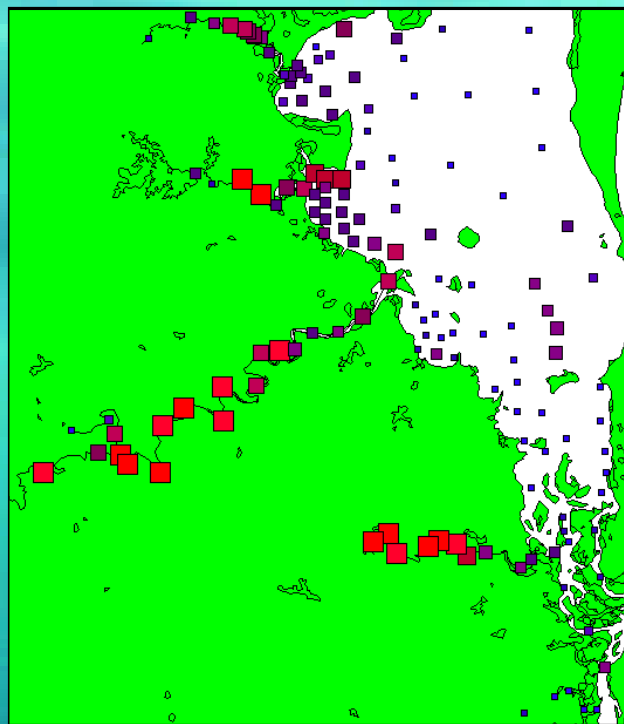
Map of Ecosystem Health in bay and rivers (large red boxes = highly degraded)

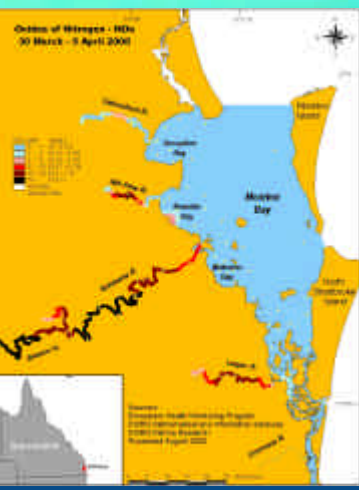
Elevated nutrients occur in the river estuaries.

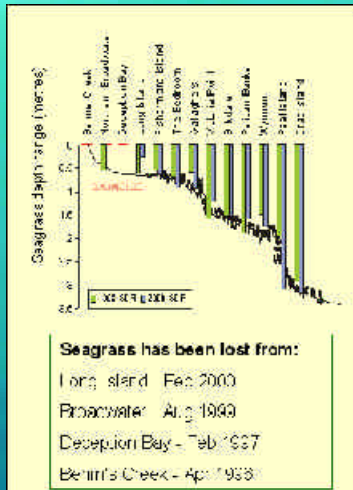
Comparison of seagrass depth ranges 1998/99 vs 2000.

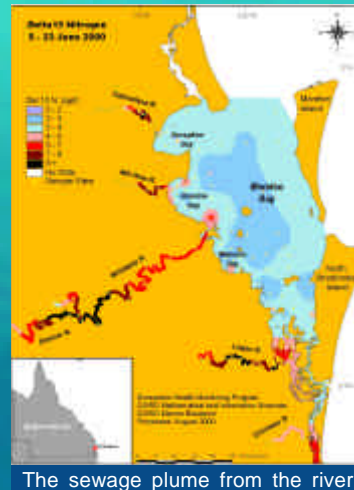
The sewage plume from the river estuaries extends into Moreton Bay.

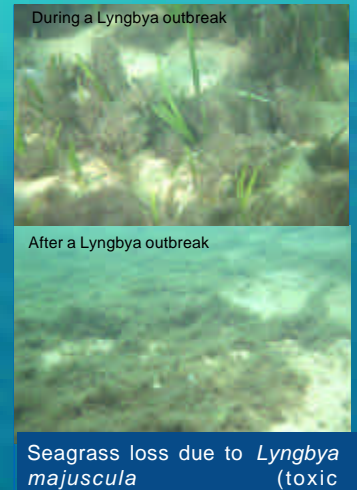
Seagrass loss due to *Lyngbya majuscula* (toxic cyanobacterium) outbreak at Amity and Moreton Banks.
