Streambank erosion repair

Case study: Streambank erosion repair in the Lockyer Valley

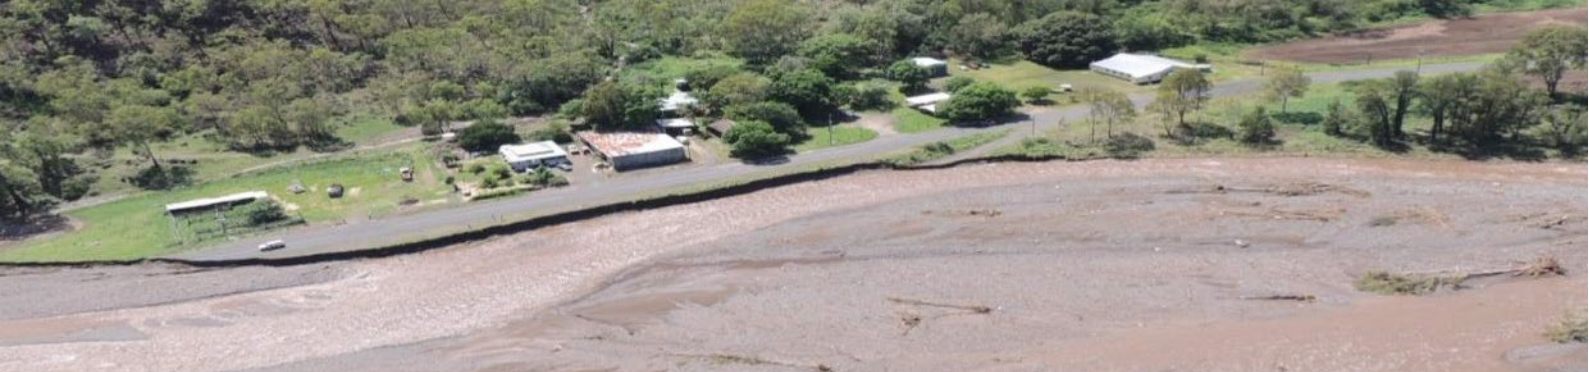
EAST HALDON: This bank was reshaped before being covered with topsoil to improve conditions for plant establishment. Care was taken not to disturb the line of trees (refer front cover and to the right of the above images) that survived the flood event and retain them along the bank toe. This example illustrates the importance of incorporating existing riparian vegetation into the streambank restoration design and, where possible, including any local topsoil reserves to create a better environment for plant growth.
